Accuracy of Boresight Equipment for the 25-Millimeter Gun of the Bradley Fighting Vehicle

Mike S. Perkins and Craig S. Wilkinson Litton Systems, Inc.

May 1988

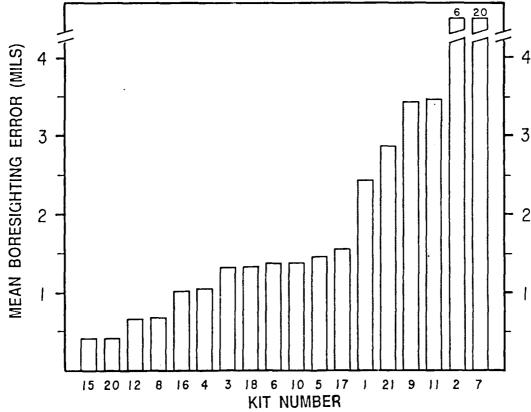
Figure 2. Mean boresighting error (mils) for each 25-mm boresight kit.

The median boresighting error for all 18 kits was 1.42 mils; Figure 2 presents data for each kit. The following summarizes the distribution of boresighting error in these kits: 2 kits (11%) were less than 0.5 mils., 2 kits (11%) were between 0.5 and 1.0 mils, 7 kits (39%) were between 1 and 2 mils, while 7 kits (39%) had values greater than 2 mils. For a particular kit, there was a substantial difference in boresighting error from one reading to the next; the mean standard deviation for a kit was 0.51 mils (see Appendix B).

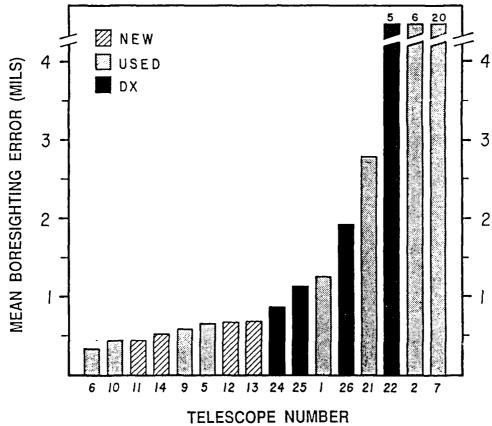
Figure 3. Mean boresighting error for New (n=4), Used (n=8), and DX (n=4)Telescopes paired with Good Adapter #12.

Good Adapter #12 was tested with a total of 16 telescopes (4 New, 8 Used, and 4 DX). The median boresighting error for all telescopes was 0.78 mils. As shown in Figure 3, only 2 Used Telescopes had values less than 0.5 mils; however, half of the telescopes had values either less than or reasonably close to 0.5 mils (range of 0.34 to 0.69 mils). Several telescopes had extremely high errors (e.g., Telescope #7), and surprisingly, the two worst telescopes were Used, and not DX, telescopes.

The median telescope rotational change (1.44 mils) was noticeably higher than boresighting error (0.78 mils). Six of 16 telescopes had a telescope rotational change less than 1 mil (i.e., the AMCCOM standard). The Good Adapter and the Good Telescope pair had the lowest rotational change with a value of 0.15 mils.

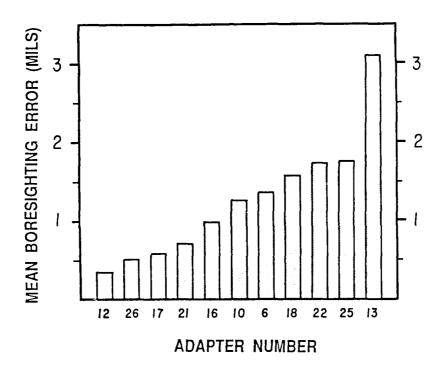
Figure 4. Mean boresighting error (mils) for adapters paired with the Good Telescope #6.

The median boresighting error for all adapters was 1.27 mils. Error for all tested adapters is presented in Figure 4. Only the Good Adapter and Good Telescope pairing had boresighting errors less than 0.5 mil. Surprisingly, the adapter (#13) with no signs of prior use had the largest error (3.1 mils).

For adapters tested with an accurate telescope, the telescope rotational change indicates the accuracy of the telescope end of the adapter. The median rotational change for all adapters was 1.32 mils. The scores were distributed as follows: 6 adapters (54%) had values less than 1 mil, 1 (9%) had a value between 1 and 2 mils, and 4 adapters (36%) had values greater than 2 mils.

Median boresighting error (1.27 mils) was very similar to telescope rotational change (1.32 mils) and adapter rotational change (1.58 mils). Boresighting error was more highly correlated with adapter rotational change (\underline{r} = 0.88) than telescope rotational change (\underline{r} = 0.36) as indicated by data presented in Appendix C.
